Cotton & Company's Assessment of
NARA's Cable Infrastructure

September 30, 2015

OIG Audit Report No. 15-15

Subject: Assessment of the Cable Infrastructure of the National Archives and
Records Administration

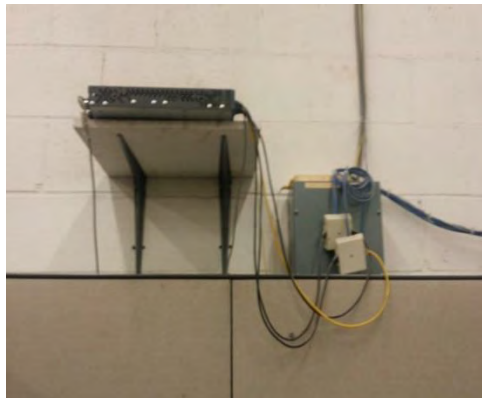
- One of the networks switches is not located in a wiring closet; instead, the device is mounted on the cave wall on a stand about 14 feet in the air. There is no cage or other protection for the device. This is inconsistent with implementation at other NARA locations, where switches are protected via locked cages, and does not comply with Directive 804 requirements to “protect power equipment and power cabling for the information system from damage and destruction.”

1. Ensure that neat cable management and labeling mechanisms are employed for all sites.
2. Ensure that all server rooms are equipped with appropriate fire detection and suppression capabilities.
3. Limit access to all server rooms to those individuals with an explicit need to access IT equipment.
4. Ensure that appropriate temperature and humidity monitoring and control mechanisms are employed for all server rooms.
5. Ensure that appropriate UPS devices are employed for hardware supporting the site's network infrastructure.
6. Ensure that all server racks, switches, and network equipment are adequately secured from unauthorized access via locked racks.

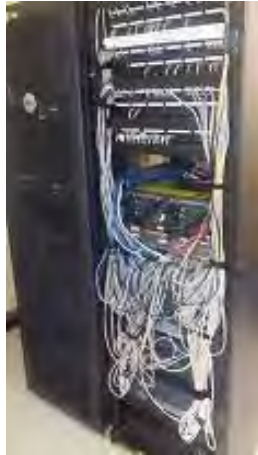
Server Rack

- **Harry S. Truman Presidential Library and Museum**
 - Wiring in the server room rack is not secure and does not employ a cable management system. The Cisco 4506 core switch is exposed, as the rack does not have a lockable front cage door. Similarly, wiring in the closet rack does not employ a cable management system, which is inconsistent with implementation at other NARA locations and does not comply with

Directive 804 requirements to “protect power equipment and power cabling for the information system from damage and destruction.”

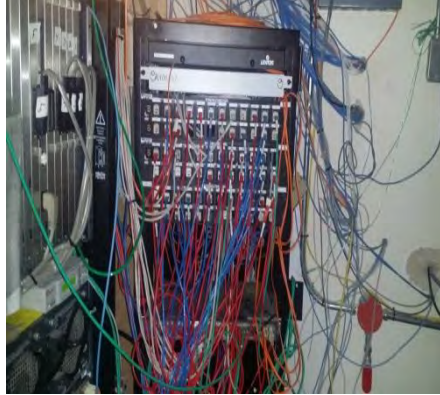
- **Lyndon B. Johnson Presidential Library and Museum**
 - The patch panel in the server room is unsecured and cannot be moved due to the length of the cable runs from various access switches into the equipment room. Cable management is not possible due to the cable lengths, which is inconsistent with implementation at other NARA locations and does not comply with Directive 804 requirements to “protect power equipment and power cabling for the information system from damage and destruction.”

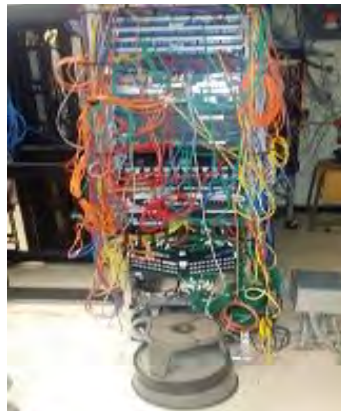
Similarly, the original wiring feed into the facility supports multiple networks (University of Texas, LBJ Foundation, and NARANet), and the library does not employ cable management for the core switches and patch panels.

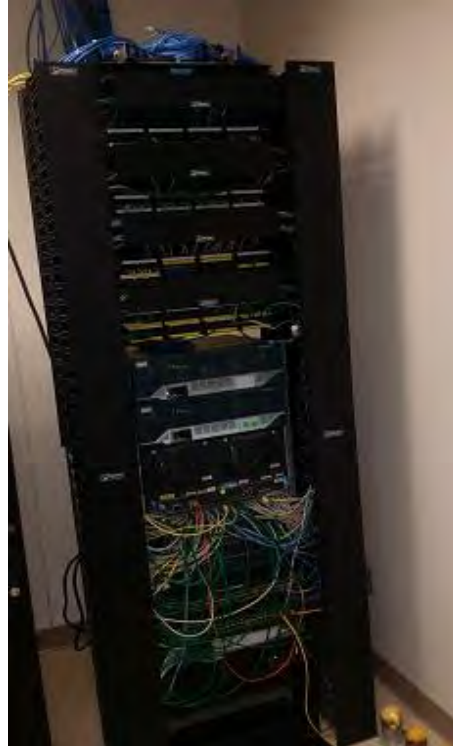
- This location does not employ humidity level monitors and controls within the server room to ensure that appropriate environmental controls are in place. This is inconsistent with implementation at other NARA locations and does not comply with Directive 804 requirements to “maintain temperature and humidity levels within the facility where the information system resides at [SSP-defined acceptable levels]; and monitor temperature and humidity levels.”
- **Fort Worth FRC**
 - Server racks at this location were not protected by a locked cage. This is inconsistent with most NARA sites and does not comply with Directive 804 requirements to “protect power equipment and power cabling for the information system from damage and destruction.”

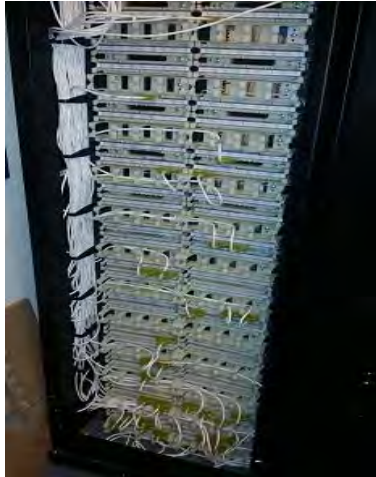
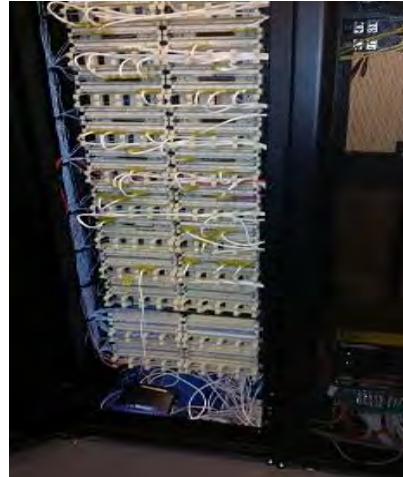
- This location does not employ humidity level monitors and controls within the server room to ensure that appropriate environmental controls are in place. This is inconsistent with implementation at other NARA locations and does not comply with Directive 804 requirements to “maintain temperature and humidity levels within the facility where the information system resides at [SSP-defined acceptable levels]; and monitor temperature and humidity levels.”
- **George W. Bush Presidential Library Library and Museum**
 - The patch panels at this location need to be replaced. Site panels were installed using “110 punch down” blocks on both sides and do not use industry-standard RJ45 jacks. This location also uses custom connectors that the FOSA created to connect panel cable runs to the site Cisco switches. This setup is inconsistent with implementation at all of the other NARA locations.

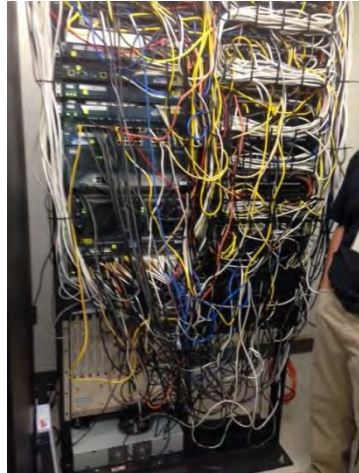
Cable Runs

- **Richard Nixon Presidential Library and Museum**
 - Cable management is not possible due to the cable lengths, which results in cables not being organized and labeled. This is inconsistent with implementation at other NARA locations and does not comply with Directive 804 requirements to “protect power equipment and power cabling for the information system from damage and destruction.”

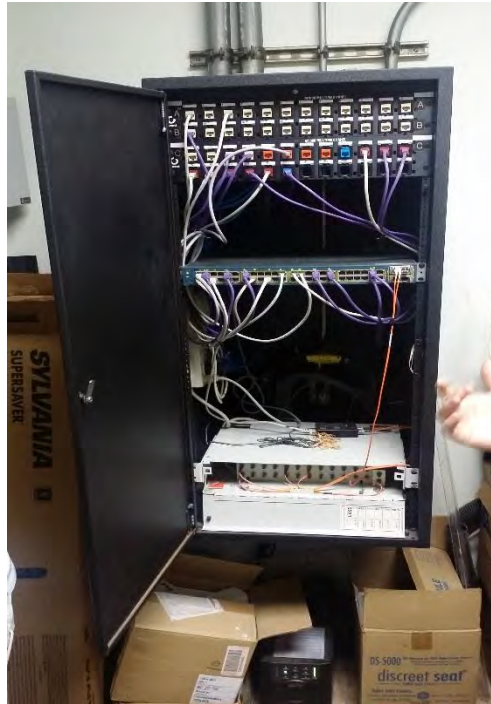
- **Dayton FRC**
 - The server room serves as a multipurpose supply and storage room. As a result, there is debris near the equipment (see below exhibit), and there is excessive access authorized for the room; only 3 of the 12 individuals authorized to access the server room have a need to access sensitive IT equipment. This is inconsistent with implementation at other NARA locations and does not comply with Directive 804 requirements to “enforce physical access authorizations for all physical access points (including designated entry/exit points) to the facility where the information system resides.”

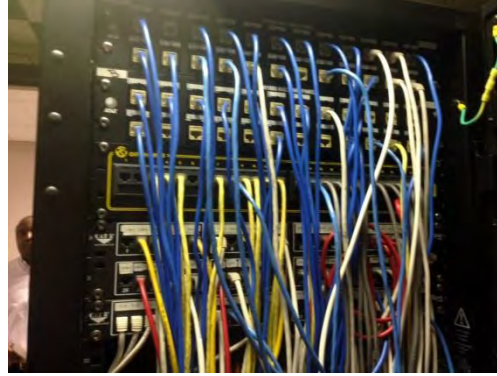
- **National Archives and FRC at Chicago**
 - Cable management is not possible due to the cable lengths, which results in cables not being organized and labeled. This is inconsistent with implementation at other NARA locations and does not comply with Directive 804 requirements to “protect power equipment and power cabling for the information system from damage and destruction.”

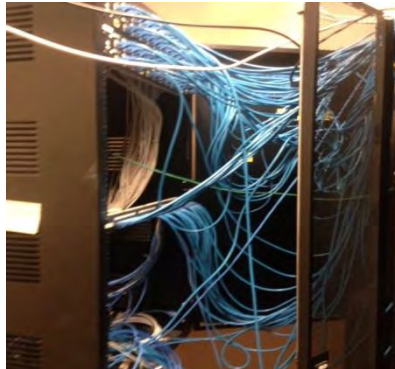
- Cable management is not possible due to the cable lengths, which results in cables not being organized and labeled. This is inconsistent with implementation at other NARA locations and does not comply with Directive 804 requirements to “protect power equipment and power cabling for the information system from damage and destruction.”

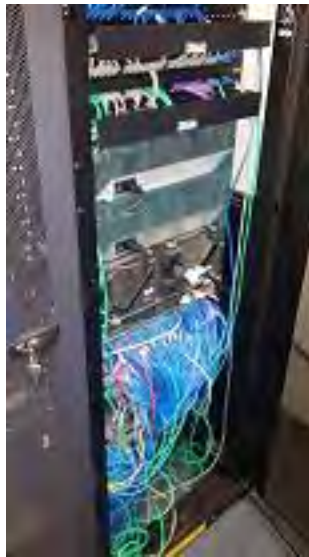
- National Archives and FRC at San Francisco: This location has utilized 90 percent of the blade chassis and switch ports.

We recommend that NARA develop and implement a plan to install additional networking capabilities at facilities that are near capacity, or develop and implement a contingency plan to support continued operations in the event that networking capabilities are maximized.

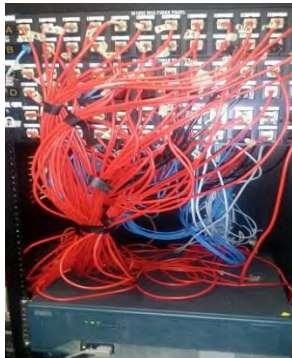
- National Archives and FRC at Seattle: This location has utilized 95 percent of the switch ports, and the patch panel is maximized.
